INTERIM REPORT OF EXPERIMENTAL CRACK
SEALING IN ASPHALTIC CONCRETE
PAVEMENTS, THULE AIR BASE, GREENLAND
8-24 AUGUST 1960

MISCELLANEOUS PAPER NO. 4-436

July 1961

U. S. Army Engineer Waterways Experiment Station
CORPS OF ENGINEERS

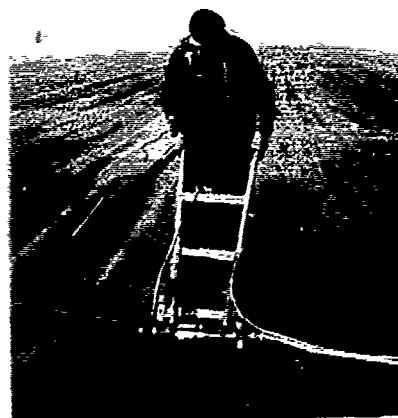
directly behind the wire brush, thus cleaning all debris from the crack. The equipment was powered by a portable air compressor unit, which was also used to blow out the prepared cuts as the final effort in cleaning. The wire brush, while possibly a somewhat crude arrangement, performed very satisfactorily. The device is shown on photograph 8.

19. After routing was completed, the groove was cleaned with a wire brush (photograph 8), and final cleaning prior to sealing was accomplished with a jet of compressed air.

Photograph 8. Wire brush apparatus fabricated on site to clean cracks prior to sealing.

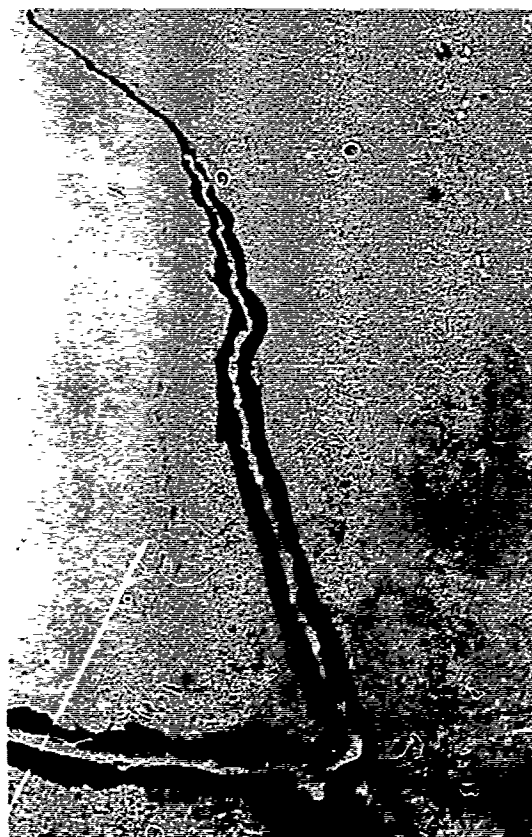
Photograph 99. Crack No. 12 on northeast
wall of room.

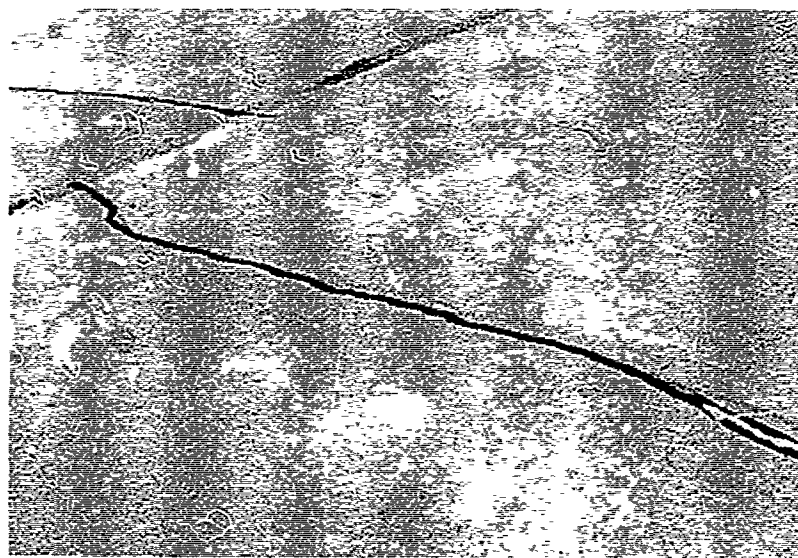
Photograph 100. Crack No. 13 on northeast
wall of room.
